MISCELLANEOUS PAPER SL-79-18

6  
**NONDESTRUCTIVE TESTING OF CONCRETE  
T-WALLS, ATCHAFALAYA BASIN PROTECTION  
LEVEES, NEW ORLEANS DISTRICT**

10  
**Henry T. Thornton, Jr.**

14  
August 1979  
Final Report

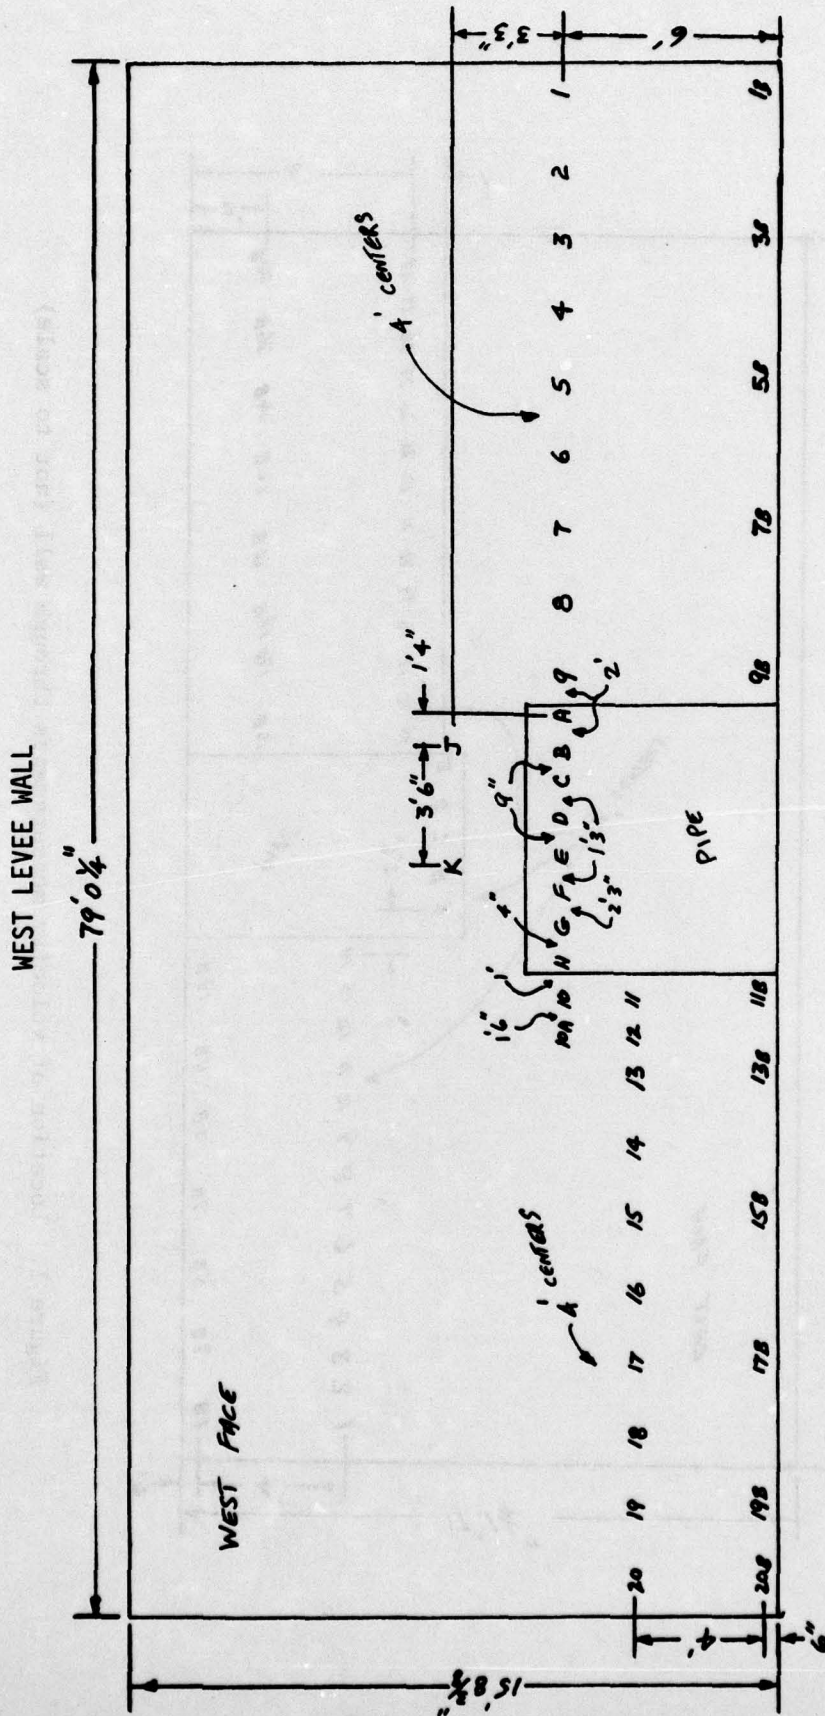
Figure 2. Location of velocity measurements through wall (not to scale)

3. Figures 1 and 2 show the locations and dimensions for stations established on the wall for making the ultrasonic velocity measurements. Station locations were selected to yield information on possible unseen defects in critical areas, i.e., near intersections between the base of the wall and the slab, and also to determine the extent and severity of visible defects. The general intent of the data station layout at both sites was to have a horizontal line of stations located at intervals along the wall on or near the poorly consolidated areas (between 4 and 6 ft above the slab), and to have a second horizontal line of stations near the intersection of the vertical wall and the slab (6 in. to 2 ft above the slab). Other stations were located according to the need to investigate specific areas. The stations in the horizontal lines near the base of the upright are designated 1B, 3B, 5B, etc., and lie on the same lines vertically as the corresponding stations above them. Stations designated by the letters A through K were located in suspect areas not covered by the previously mentioned horizontal lines of stations (Photos 5 and 6). The face of the protected side of each wall has a vertical slope of 39/64 in. per ft. Therefore, any change in vertical elevation on the wall is accompanied by a change in distance through the wall section. For evaluation purposes the velocities obtained from data stations at the same elevation at each wall are grouped. Consequently, there are several groups of velocities reported for the east wall, and several groups reported for the west wall. This was done to separate velocities by elevation or area.

Velocities obtained at stations 3, 11, and 15 of groups 1 and 2 indicate areas of inferior quality concrete located along the visible seam in the west wall. The 11 measurements made along the base of the vertical wall (group 3) produced 1 velocity (station 11B) which is considerably lower than the others. This anomaly goes without explanation except for the possibility of incomplete consolidation. It is noted that station 11, which is directly above station 11B, also produced a low velocity. It is also noted that stations 9B and 10 are very near the lowest velocities in their respective groups, although they are within one standard deviation of their respective group means. The point is that these stations are all very close to that section of concrete which houses the casing collar (see Photo 7 and Figure 2). The additional steel reinforcing and irregular form shape could have contributed to incomplete consolidation in this area. Stations A through K were established to provide data in the allegedly patched and smoothed-over area in the west wall (see Photo 3 and Figure 2). As in the east wall, the velocities obtained from this group of stations generally confirm the presence of inferior quality concrete. The mean velocity for group 4 is 15 percent lower than the mean of groups 1-3 collectively.

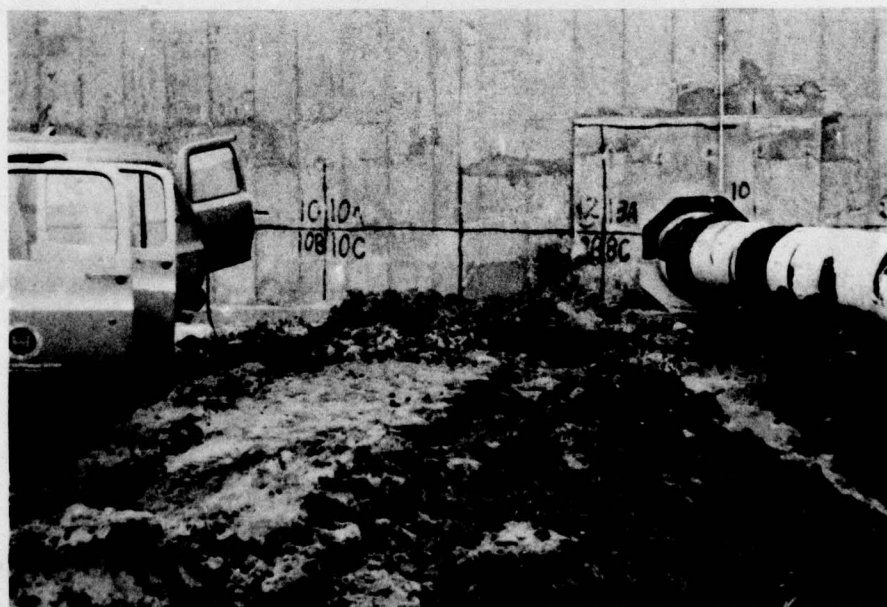
1. Nondestructive testing (NDT) measurements were made on two concrete inverted T-walls constructed in the east and west protection levees of the Atchafalaya Basin. These T-walls are to accommodate the Weeks Island-St. James 36-in.\* crude oil pipeline that will cross the basin, intersecting the east and west protection levees near Belle River and Centerville, La., respectively. The initial contact with the Waterways Experiment Station (WES) by New Orleans District (NOD) was a request for an ultrasonic velocity survey of the upright portion of the T-walls in areas where visible seams of apparent inadequate compaction and exposed reinforcing steel caused concern for the structural integrity of the walls (see Photos 1, 2, 3, and 4).

Photo 2. T-wall, east levee; note station numbers and letters on wall

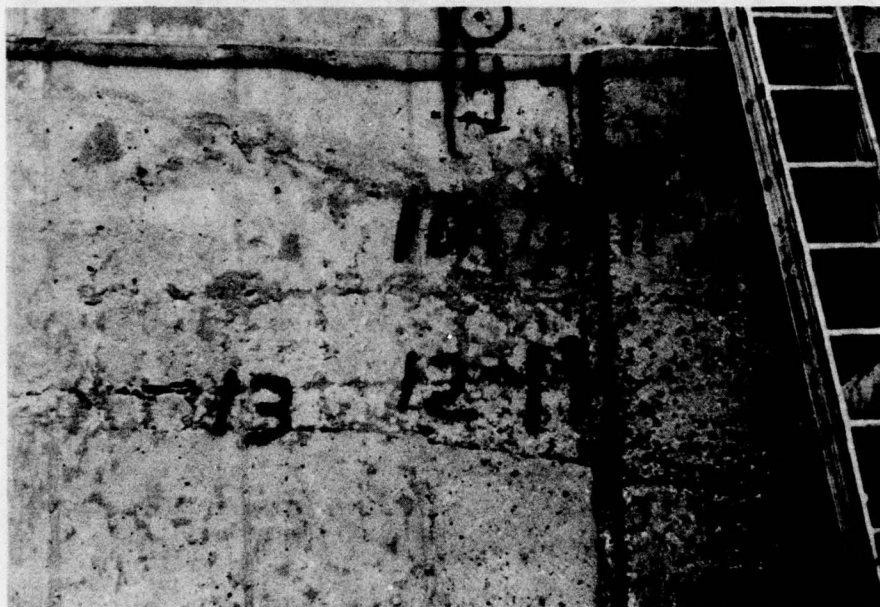
Photo 7. View showing the vertical section of concrete that houses the casing collar

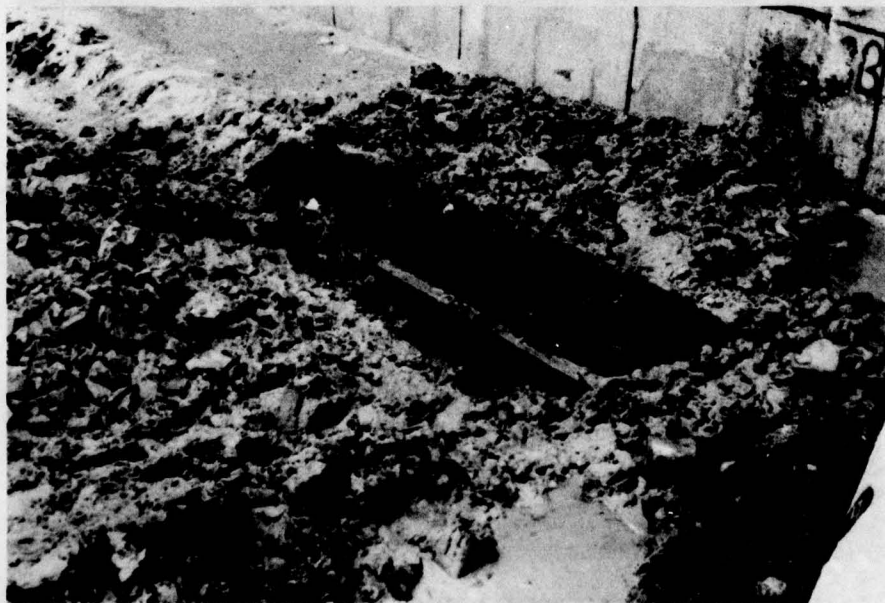
6. During the course of this investigation, the testing party learned that there was some concern on the part of NOD about the continuity of some of the prestressed concrete piles that were driven to serve as foundation for the T-wall structures. Two rows of piles were driven on 4-ft centers to depths of approximately 80 ft under each wall; 34 piles (14 by 14 in.) under the east wall and 40 piles (12 by 12 in.) under the west wall. Figure 3 shows a typical section through a wall. On 16 January 1979, with verbal authority from NOD, Messrs. Henry Thornton and Dan Wilson returned to the east protection wall and attempted to make determinations concerning the continuity of the foundation piles using the pulse-echo technique. This technique is in the developmental stage. It entails the introduction of an excitation pulse at the surface of a structure and receiving at the same surface reflections, or echoes, returning from boundaries within the structure. In this case the boundaries would be the end of the pile or cracks if any were present. Attempts to excite the piles through the 2.5-ft base slab were unsuccessful. Through the efforts of Messrs. Herb Juneau and Carl Rebouche, NOD, a small portion of a pile was exposed by excavating adjacent to the base slab (see Photo 8). This was done to facilitate actual contact with the pile in the hope that a shear mode measurement in direct contact with the pile would produce better results than the previous indirect (through the slab) longitudinal test. This was not the case. Although the efforts made in the excavation, and in the testing, were good, the small portion of pile exposed and the very close and undesirable working conditions made it very difficult to perform the test properly. Little confidence, if any, was generated for this method of testing in this particular application, and an oral report was made, as such, to NOD. The desire for information on the condition of the piles and the fact that the shear mode pulse-echo tests had been made under undesirable conditions prompted a request by NOD to reevaluate the applicability of the shear mode test if it could be done under more favorable conditions, i.e., more extensive excavation with more pile area exposed. On receiving this request, a decision was made to do calibration tests

Photo 8. Portion of pile exposed by excavation

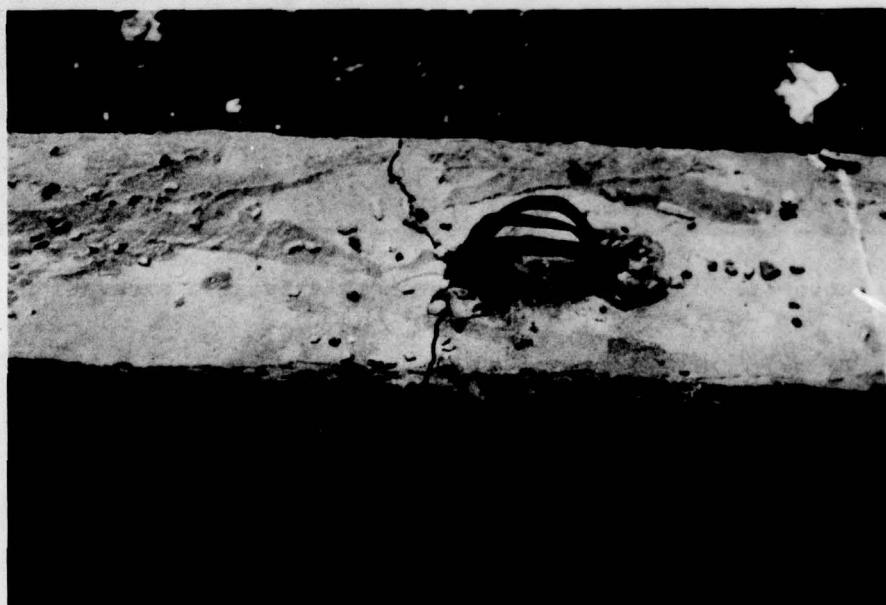
on companion piles which had not been driven. On 23 January 1979 Messrs. Henry Thornton and Michel Alexander travelled to the precast pile yard of Marine Concrete Structures, Inc., Metairie, La. Both shear mode and longitudinal mode pulse-echo measurements were made on cracked and uncracked piles. No difficulty was encountered in the measurements. Both shear and longitudinal echoes were received from the ends of the piles, and from the crack in the pile (see Photos 9 and 10). The results of these tests were considered to be excellent. With these results, and with expectations of having better access to the driven piles at the site, it was decided that there was at least an even chance for success. On 21 February 1979 Messrs. Thornton and Alexander returned to the east wall. More extensive excavation had been performed, but the exposed portions of the piles were still small (see Photo 11). After 2 days of intensive, exhaustive testing with no success the work was terminated. It was concluded that the damping factors of the surrounding soil and the 2.5-ft concrete cap were so high that the pile could not respond to the exciting impulse in either mode of test. An impulse of much higher energy than that available at the time would be required to excite piles in such an environment.

Photo 10. View showing cracked pile
